Benefit-Cost Analysis Methods Summary

2022 FEMA BRIC Grant Application

Town of Mebane, NC – Sanitary Sewer Rehabilitation Project

Inflow and Infiltration Study

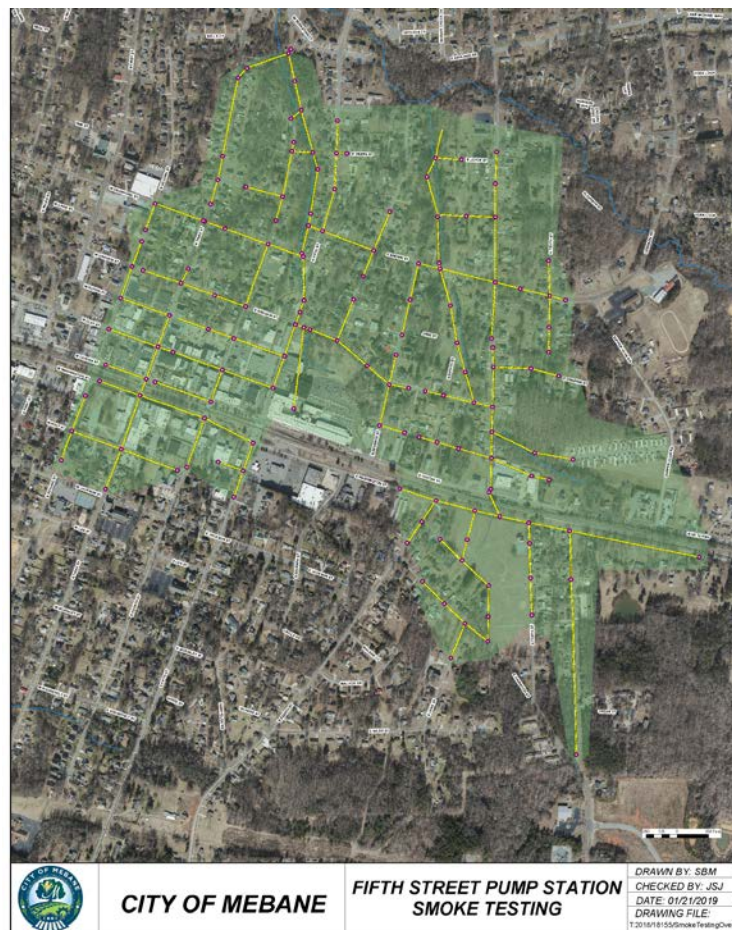
Figure 10: 5th Street Pump Station Sewershed

The 5th Street Pump Station is made up of approximately 16 miles of gravity sewer serving the downtown district and mostly residential properties that includes historic neighborhoods, multi-family buildings, as well as some newer development from the 2000's. Utilizing results from a 2012 flow-monitoring report, AWCK narrowed down the significant I&I concern to an approximately 8.5-mile total length of gravity sewer. This reduced sewershed area includes older neighborhoods, the historic downtown, and an apartment complex, eliminating the newer developments, where I&I is expected not to be a major concern. Upon the construction of the North Regional Pump Station, the 5th Street Pump Station is now by-passed by most wastewater flow, only in use during and after strong storm events when the lines are surcharged due to I&I. Wastewater that flows into 5th Street Pump Station is forced to a gravity manhole less than one mile away, where it is carried through a 12" gravity sewer to the WWTP.

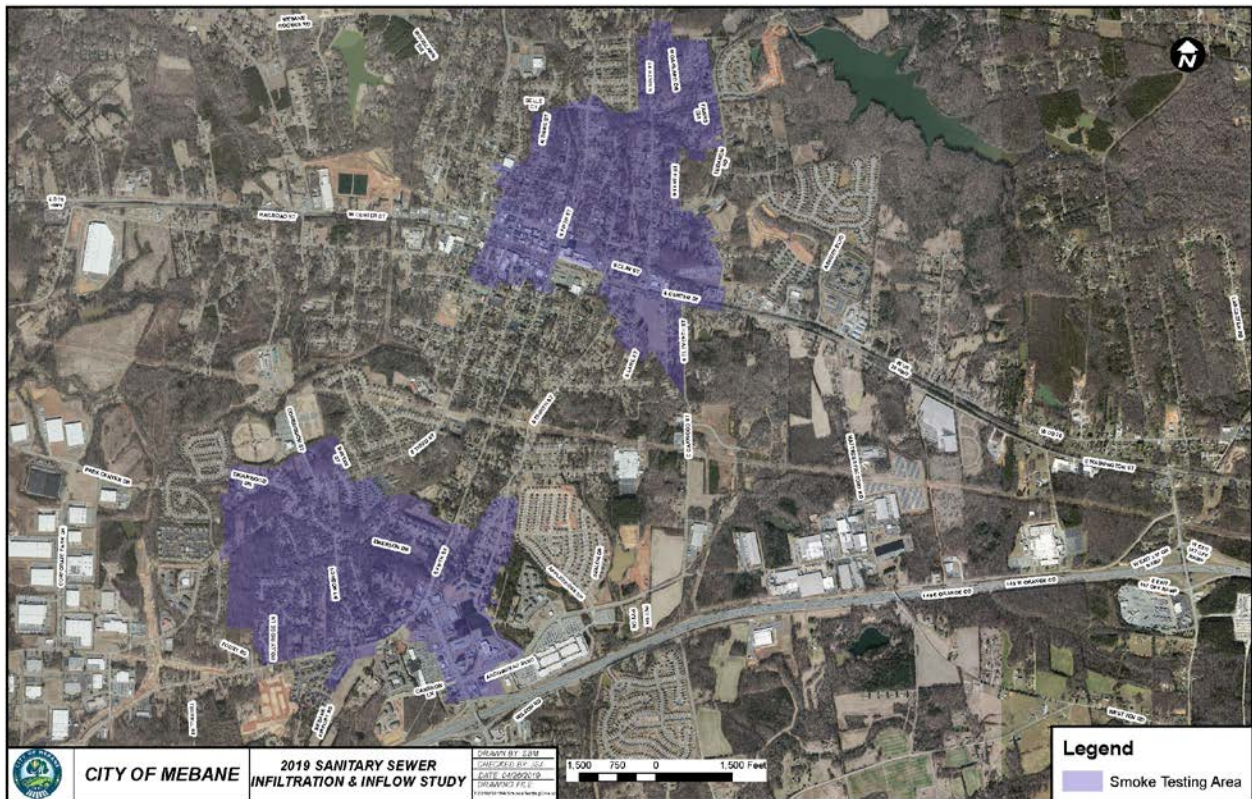
Figure 12: Smoke Testing Areas

AWCK, with the City of Mebane's assistance, identified two of the most essential outfalls to be tested. AWCK used liquid smoke, a manhole liquid smoke blower, and GIS unit to smoke test the sewer lines and map points and areas of concern for the City. To smoke test sections of line, AWCK personnel first identified a manhole that was both accessible for the smoke machine and undamaged, so to maximize smoke being blown into the collection system. After placing the smoke machine on the manhole, the smoke engine was started and smoke allowed to blow into the manhole, filling the connecting line(s). AWCK then studied each leg of sewer tied into the manhole by walking along each line, simultaneously looking for signs of smoke rising from the ground, houses, cleanouts, and manholes. Smoke machine setups allowed for various lengths of

sewer to be tested. Each setup time was dependent on several factors; number of lines in/out, size and slope of lines, number of services in each line, and volume of smoke exiting through needed repairs. A setup was complete once visible smoke was no longer seen at a manhole along the study walk, and all areas and points of concern were recorded using the Trimble GPS system.

After the field investigation was complete all GIS identified points were uploaded into map packages containing the City of Mebane Collection System. Approximately 89,000 LF of sanitary sewer line was tested between the two sewersheds, and in total, 360 sewer manholes were tested (209 in 3rd Street, 151 in 5th Street), 27 of which were previously unmapped. Sections of unmapped manholes and lines were mapped using the handheld GIS unit and added to the City of Mebane's GIS database.

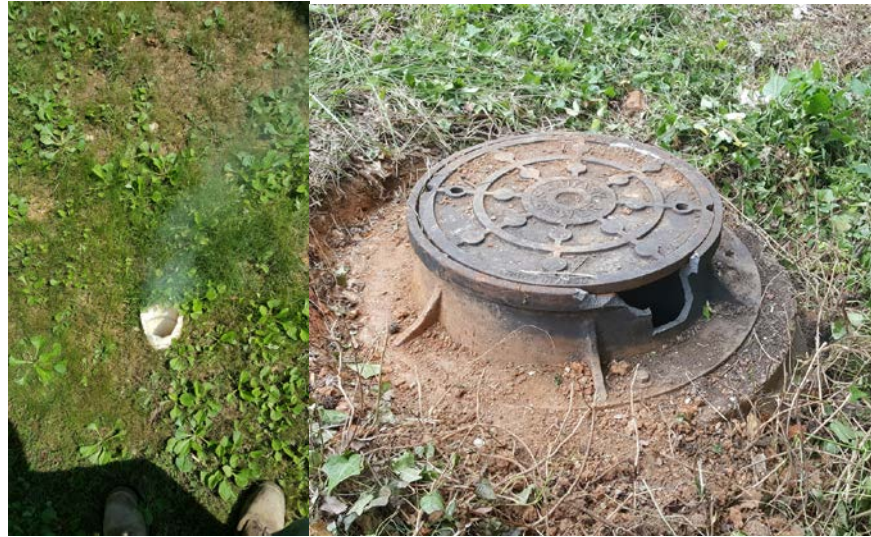
Figure 13: Damaged Cleanout Cap and Manhole Ring

The 3rd Street and 5th Street Pump Stations identified 87 cleanouts that were either damaged needing repair or missing parts, allowing considerable amounts of inflow into the sewer system during wet weather. Many of these cleanouts were found to be flush with the surrounding grade, some on slopes or in low areas, creating easy access points for inflow. With a 4-inch sanitary sewer service having the ability to carry a maximum capacity of 240 gallons per minute, those susceptible to inflow will likely allow any accessible water to enter the system. Ten manholes were found to have some form of structural damage, ranging from cracks in cones to broken ring and covers, each allowing inflow and infiltration. These infrastructure flaws are not uncommon to discover during any I&I study but are problematic for inflow and should be addressed.

Damaged cleanouts, manholes, and point repairs were grouped into the same classification for priority and repair type. The identified locations are easily accessible, repair materials are relatively inexpensive, and the work requires excavating and repairs that City of Mebane Utilities Department are comfortable with performing. Setting these concerns as high priority and repairing in-house will eliminate potentially high volumes of stormwater from entering the system.

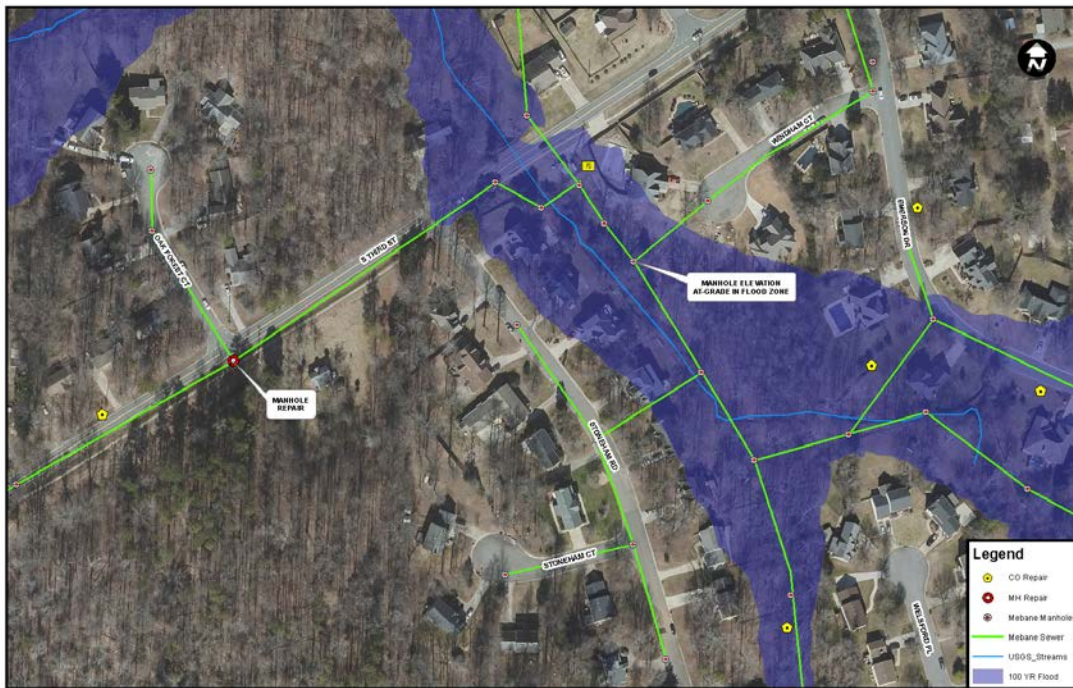
Figure 14: 5th Street Manholes with Perforated Lids in Flood Zone

Smoke testing the main outfall line for both 3rd Street and 5th Street Pump Stations revealed the current state of numerous manholes. The North Carolina Department of Environment and Natural Resources requires new manholes placed in the 100-year flood zone to be installed using watertight lids and vented every 1,000 feet or to be raised 24” above the 100-year flood elevation. Most structures appeared not to adhere to these criteria, with numerous manholes consisted of perforated lids within the flood zone, leaving them at risk to rising stream elevation during flooding. Non-watertight manholes that become overtopped can be the source of significant inflow during storm events.

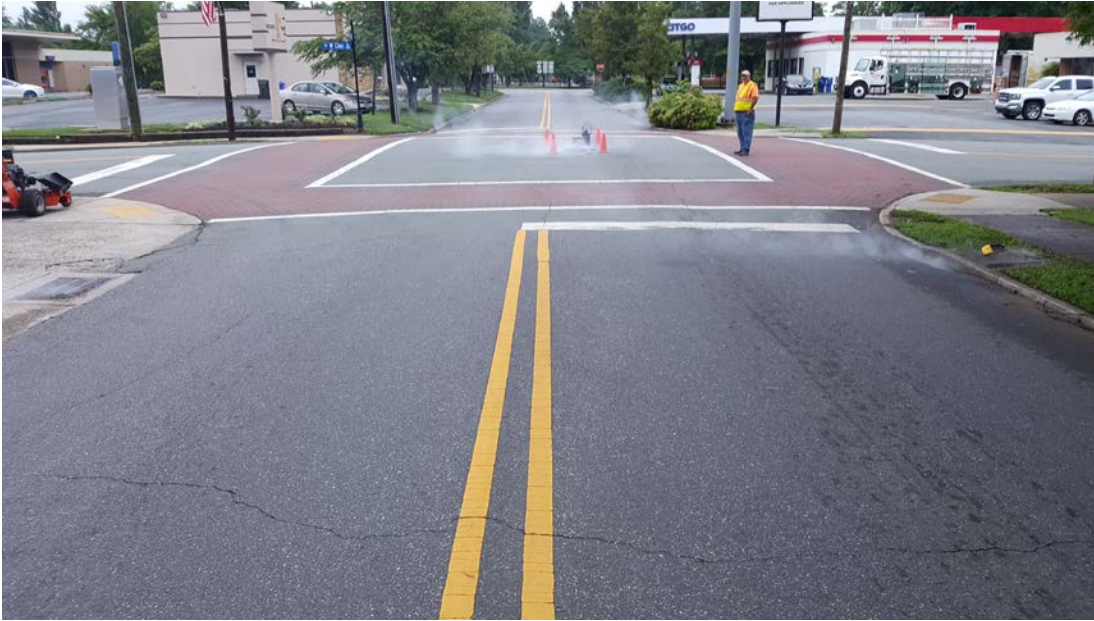
Figure 15: Typical Smoke from Storm Drainage via Sewer System Smoking

Smoke testing of the 5th Street Pump Station uncovered several I&I locations, including numerous potential sanitary sewer/storm sewer cross connections. Downtown Mebane and the immediate surrounding areas, part of the original square mile of city limits, is home to some of the oldest sanitary sewer infrastructure in the City, and was carefully studied due to the high probability of I&I. Through investigation, there were 24 different locations of smoke appearing from storm drain structures. Each separate site is subject to a differing size watershed and inflow calculation, so individual analysis was not performed. As reference, however, a 0.50-acre watershed would create almost 13,000 gallons of stormwater runoff during a 1" storm event. These issues could be cross connections, pipe degrading, joint separations, or a combination of these problems.

This project is centered around the possible storm drain cross connections and interconnections with the 5th Street Pump Station sanitary sewer outfall. Investigation will include roof drain analysis in the field, loading various roof drains and observing their downstream connections. Additionally, video of the storm drain and sanitary sewer line will be recorded in the areas of concern and studied for any defects or irregular alignments surrounding the existing lines. The field investigation and result analysis can be done through joint efforts between the City of Mebane Public Works Department, Alley, Williams, Carmen & King, and a contractor to address the issues identified. The process for this work would be the following:
